**TEARDOWN REPORT  
OF TWO MODEL TPE331-10T-515K TURBOPROP ENGINES  
SERIAL NUMBER P-79297C AND P-79001C**

**October 8, 2014**

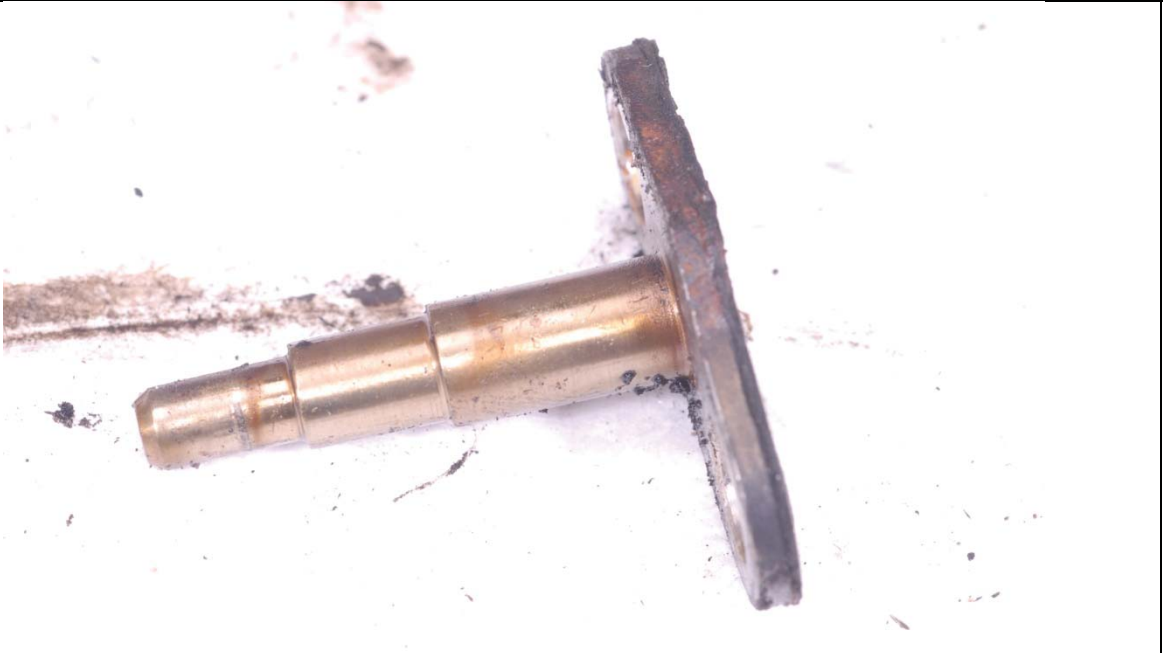
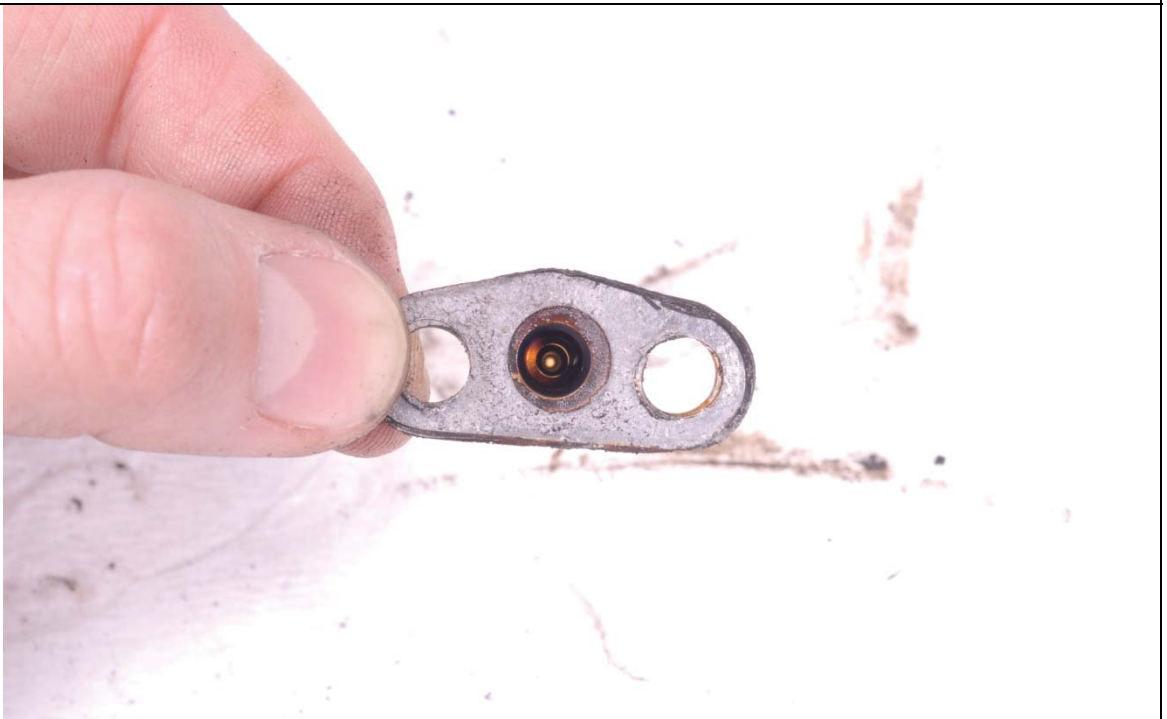
- The turbine oil inlet tube and jet were intact.
  - The turbine oil inlet jet appeared to be unobstructed. (Figure 174)
- (n) Turbine Air/Oil Carbon Seal: (Figure 175)

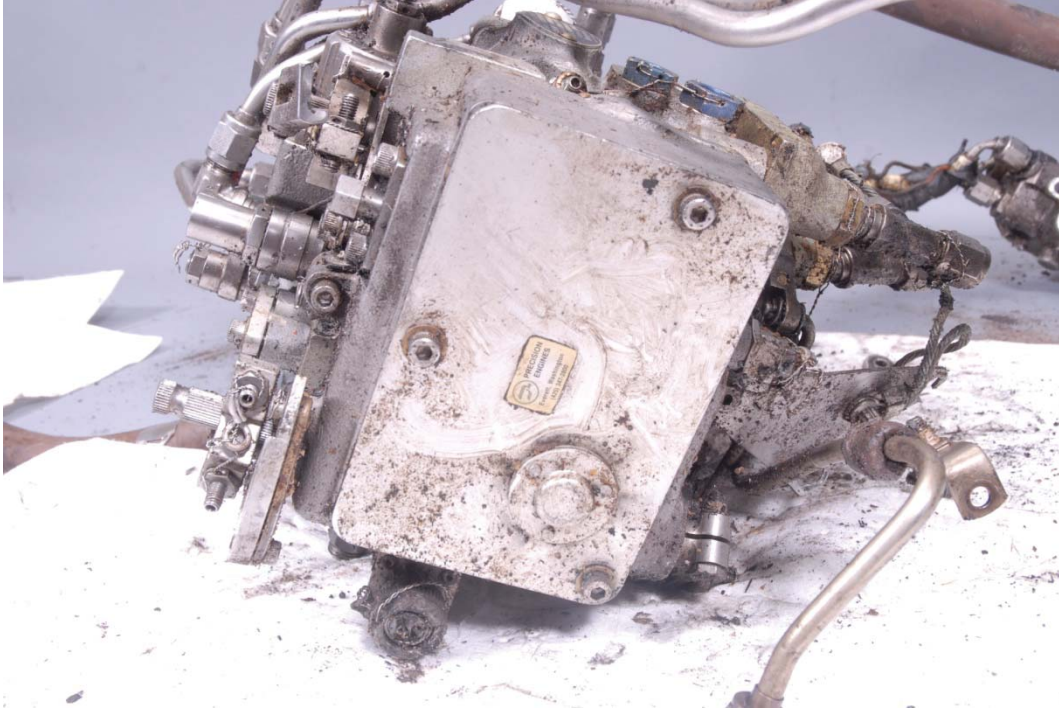
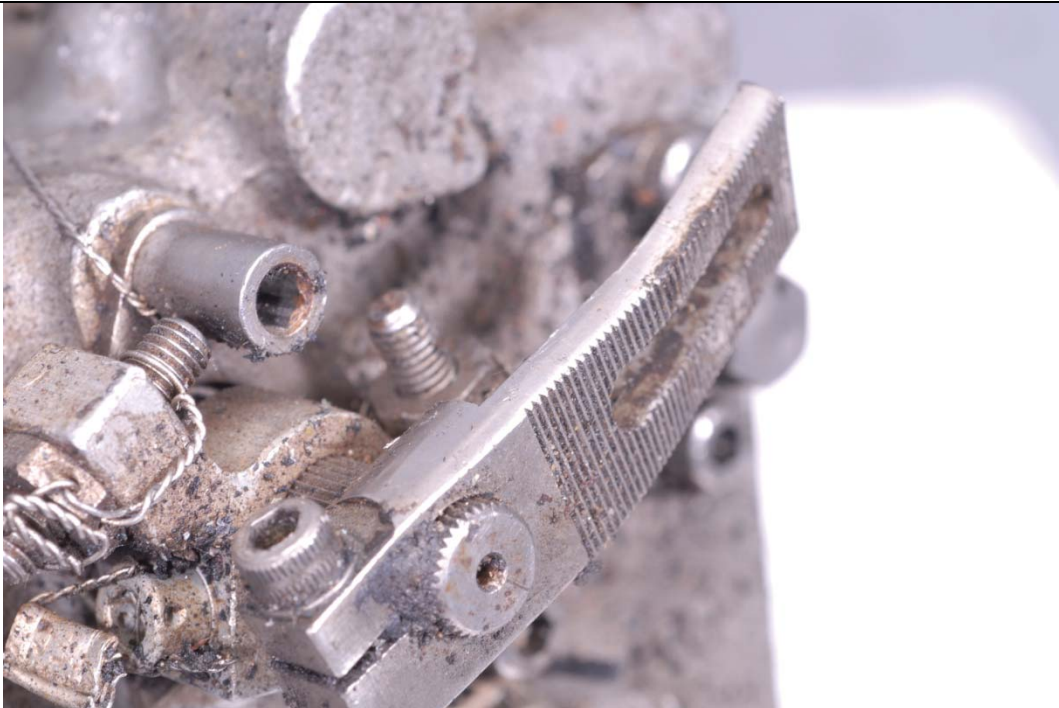
**Figure 182. P-79297C, Fuel Control**

- There was earthen debris adhering to the external surfaces of the fuel pump.
- (c) Fuel Control: (Figure 182 and Figure 183)
  - Part Number: 2549118-42

- The fuel control assembly power lever shaft rotated freely.
  - The fuel control assembly underspeed governor input shaft rotated with resistance.
  - The fuel control assembly underspeed governor input shaft lever was bent. (Figure 184)

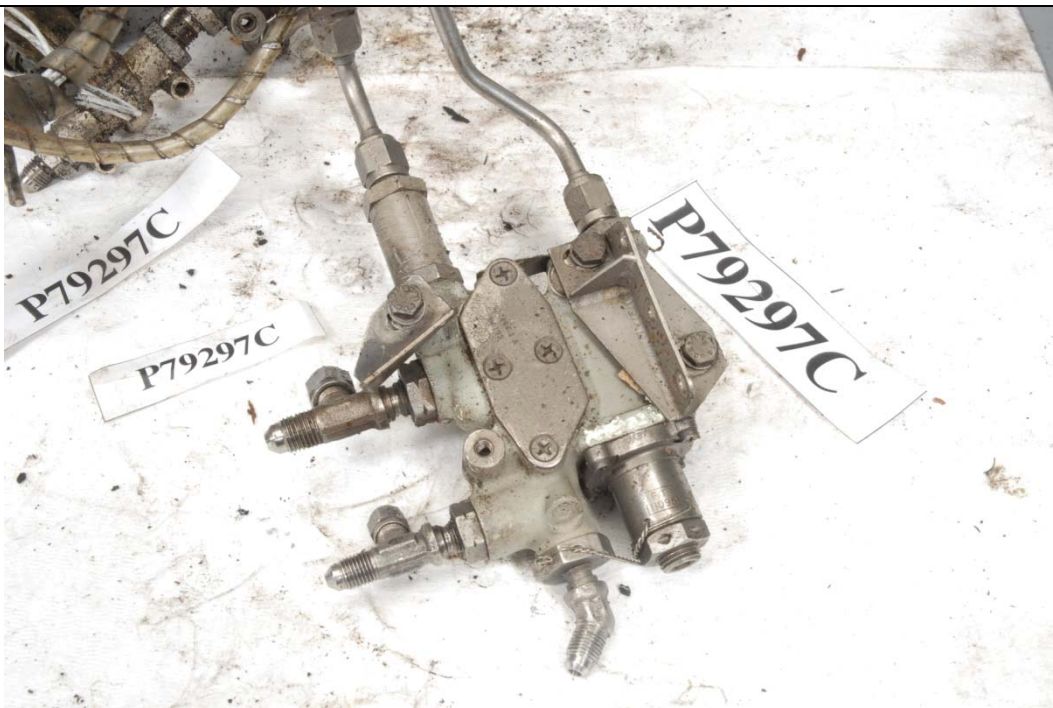
**Figure 185. P-79297C, Fuel Filter**

- (d) Fuel Filter: (Figure 185)
  - The fuel filter was not accessed during the examination.
- (e) Fuel Flow Divider: (Figure 186 and Figure 187)
  - Part Number: 394408-8-1

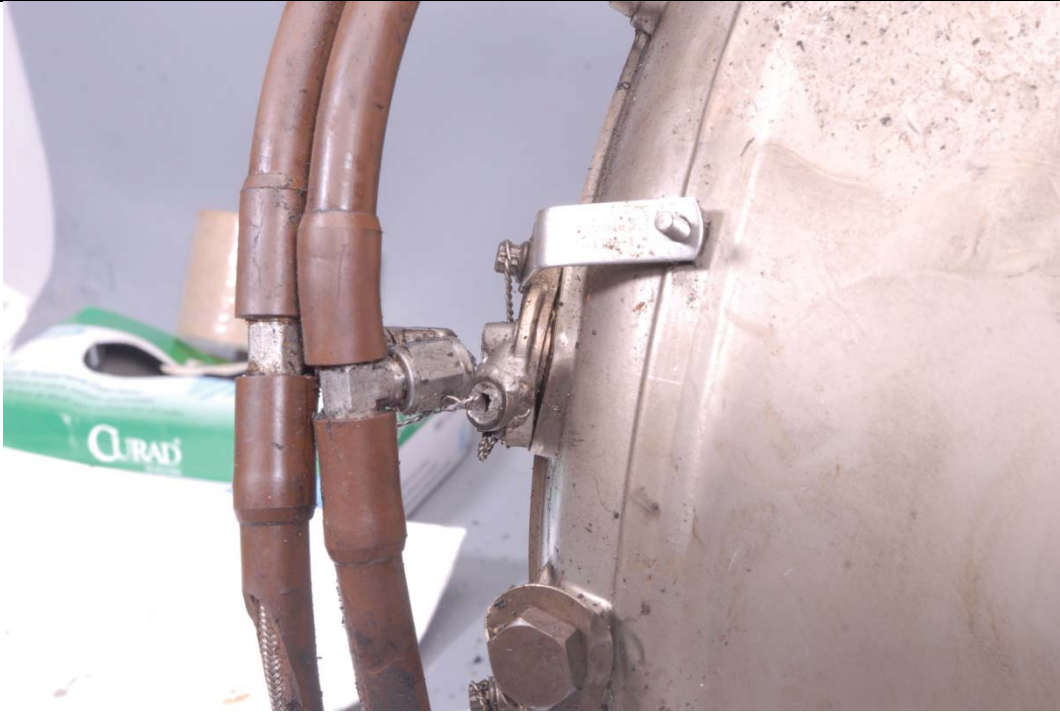
**Figure 188. P-79297C, Fuel Manifold Hose Assembly**

- (f) Fuel Manifold Hose Assembly: (Figure 188)
  - The fuel manifold hose assembly was not removed from the combustor plenum case.
  - The exterior surfaces of the fuel manifold hose assembly were covered with a black ash-like debris.

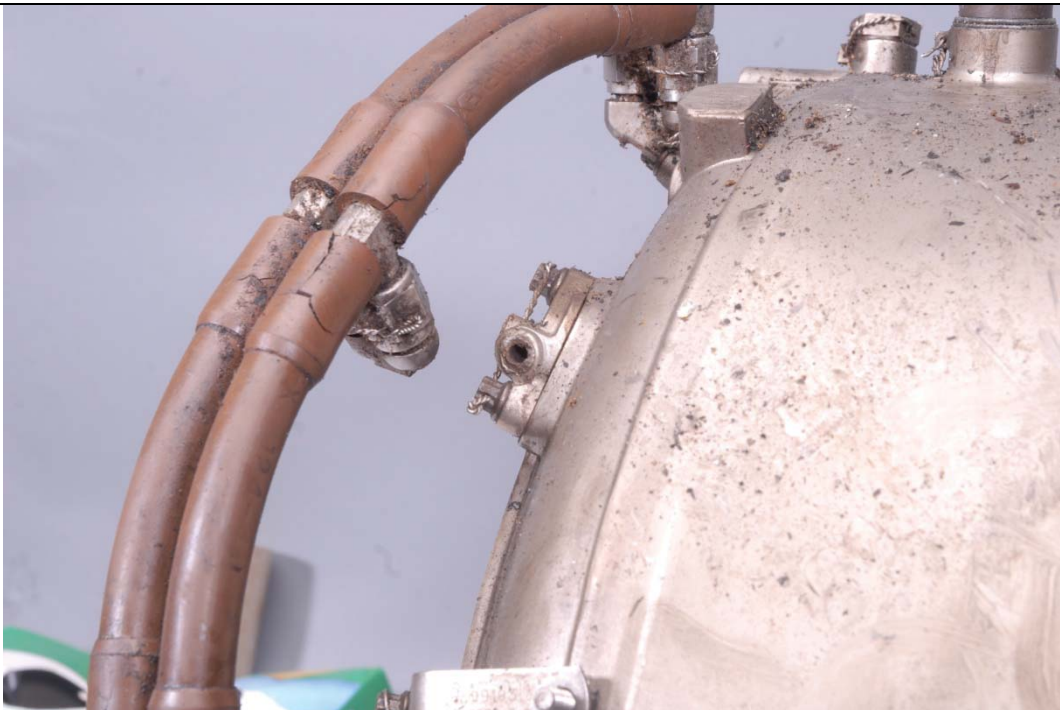
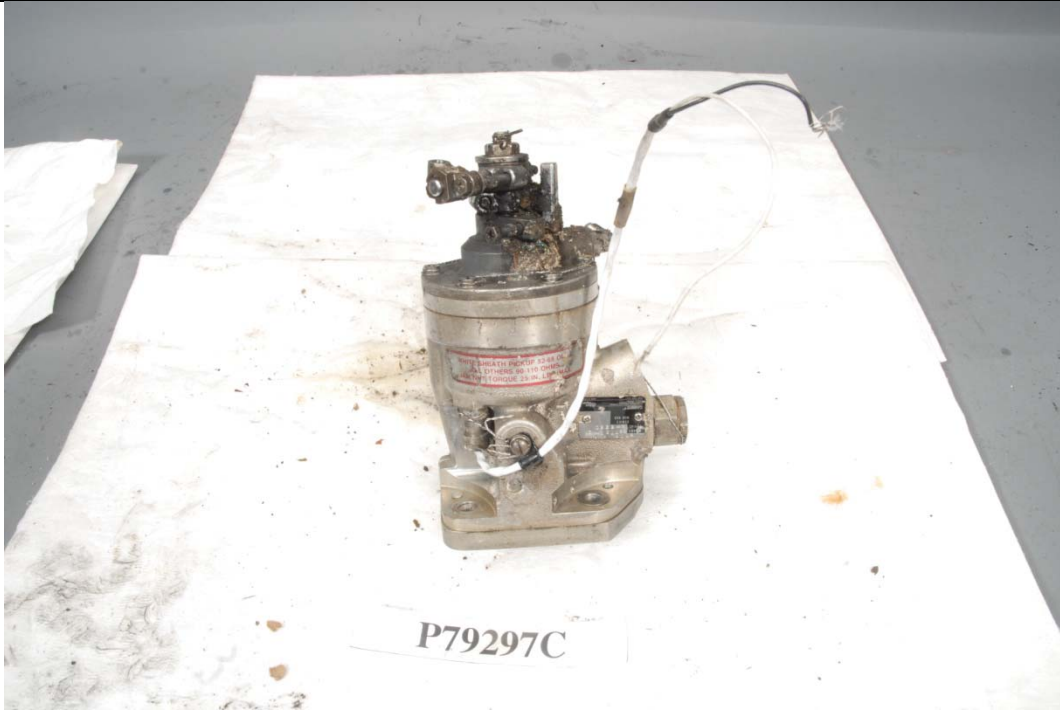
**Figure 189. P-79297C, Fuel Manifold Hose Assembly**

- Insulation was missing from small portions of the fuel manifold hoses.
  - The fuel manifold hose assembly was separated in two locations adjacent to two fuel nozzles. (Figure 189 and Figure 190)

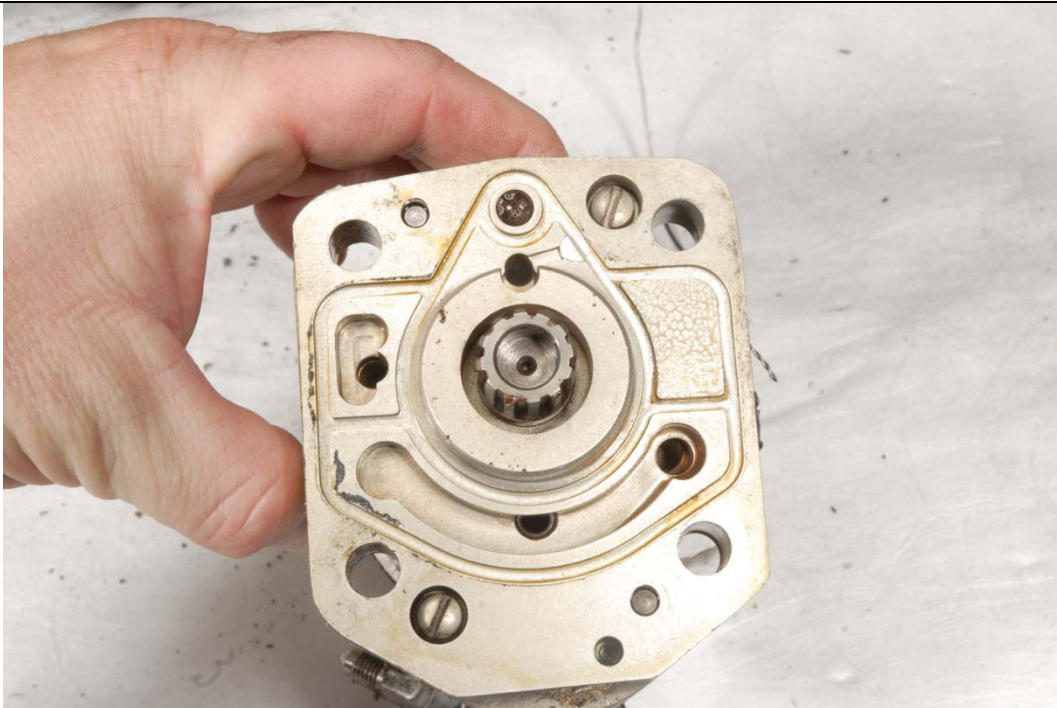
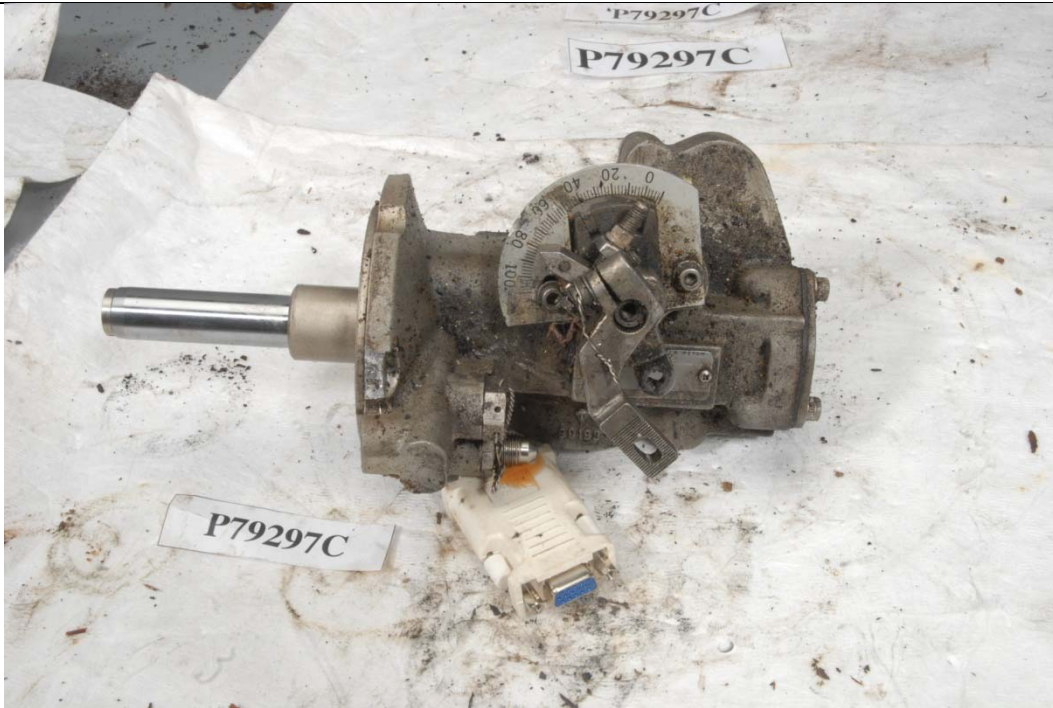
**Figure 191. P-79297C, Propeller Governor**

- (g) Propeller Governor: (Figure 191 and Figure 192)
  - Part Number: 894418-6
  - Serial Number: 1712926 E
  - The propeller governor drive shaft and control lever were free to rotate.

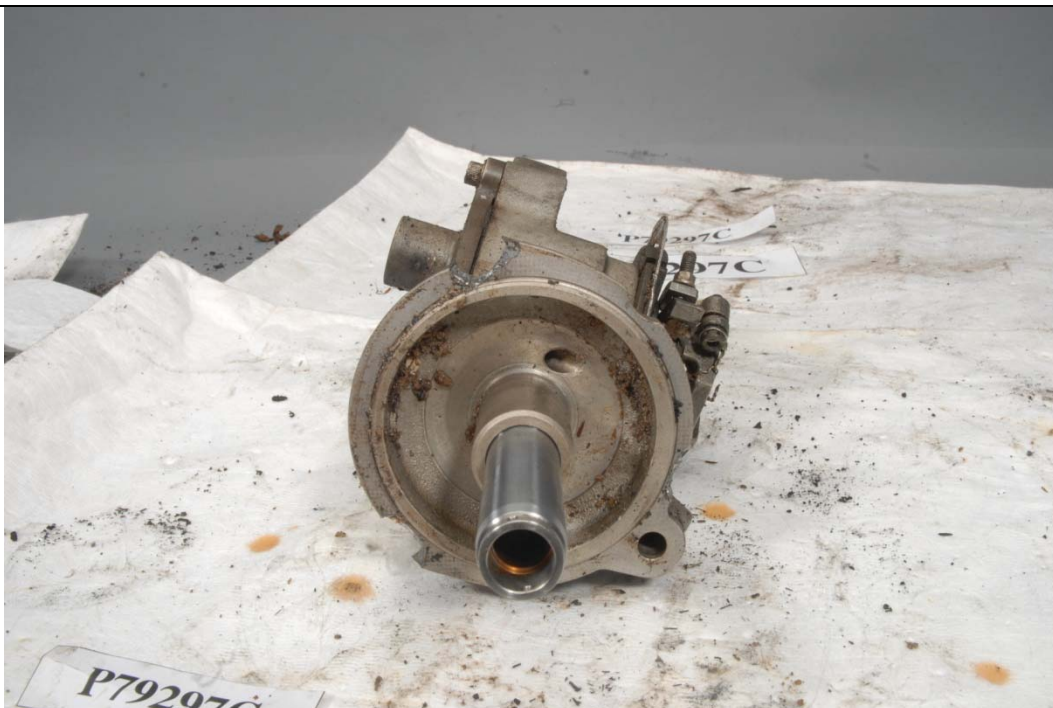
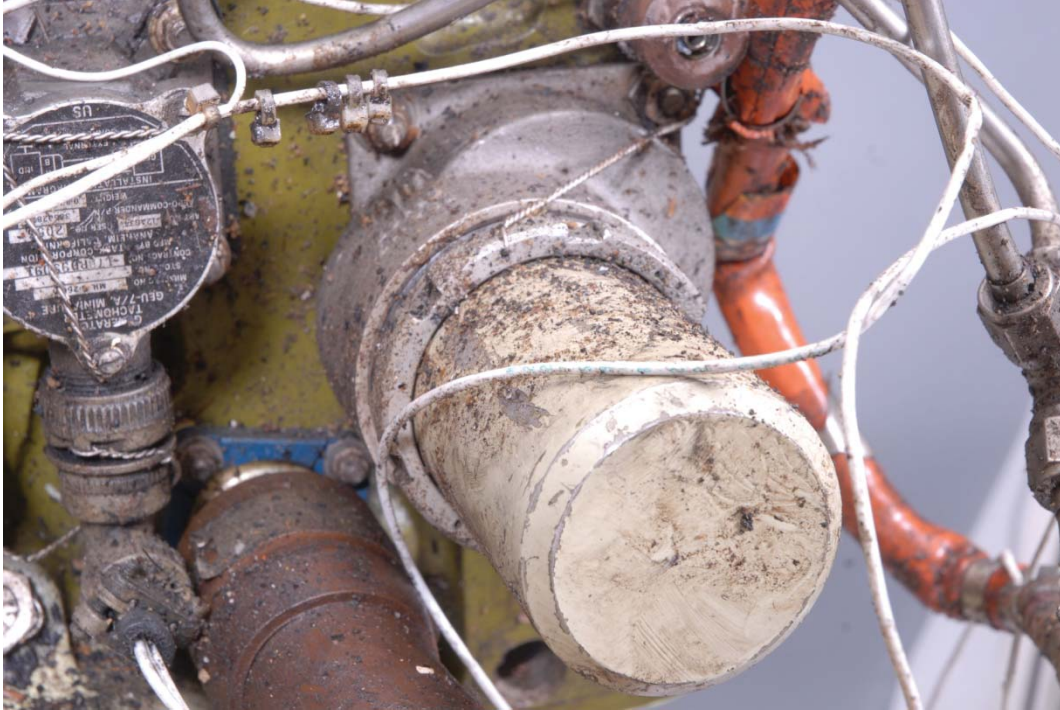
**Figure 193.** P-79297C, Propeller Pitch Control

- (h) Propeller Pitch Control: (Figure 193 and Figure 194)
  - Part Number: 895481-17
  - Serial Number: P-7859C
  - The propeller pitch control was not disassembled.

- The propeller pitch control sleeve / cam were free to move.
  - The propeller pitch control sleeve guide pin was not accessed
- (i) Oil Filter: (Figure 195)

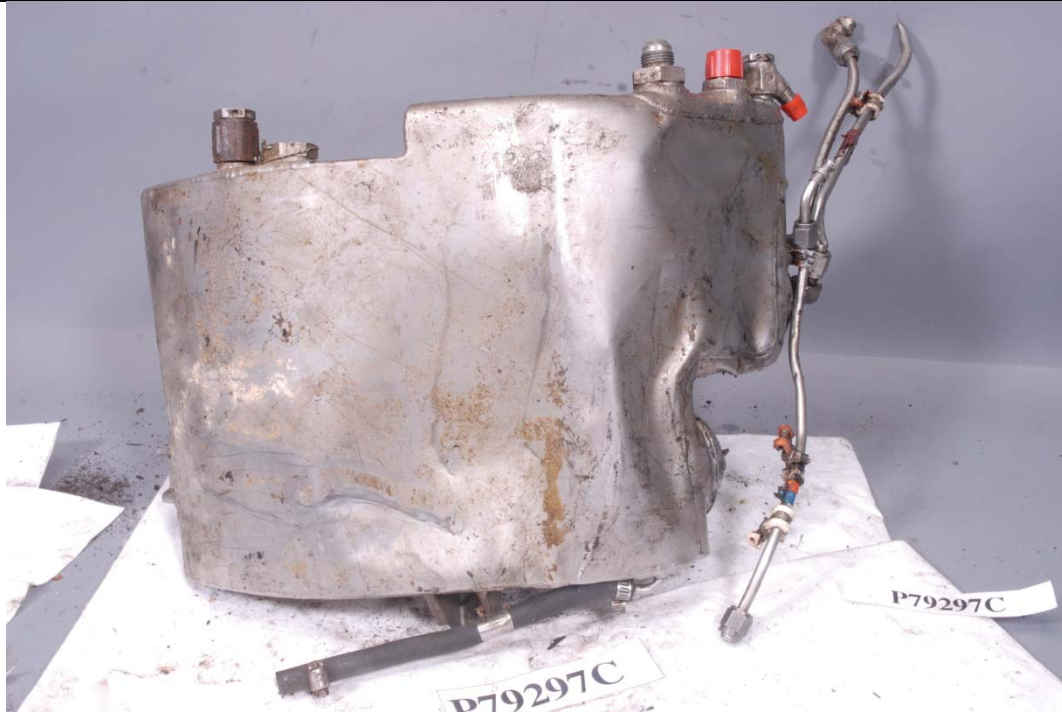
**Figure 196. P-79297C, Oil Tank**

- (j) Oil Tank: (Figure 196)
  - The oil tank was intact.
  - The oil tank was dented in several locations. (Figure 197)
  - The oil tank contained residual oil.

- The exterior surfaces of the oil tank were covered with earthen debris.
- (k) Ignition Exciter: (Figure 198 and Figure 199)
  - Part Number: 10-378400-5 C

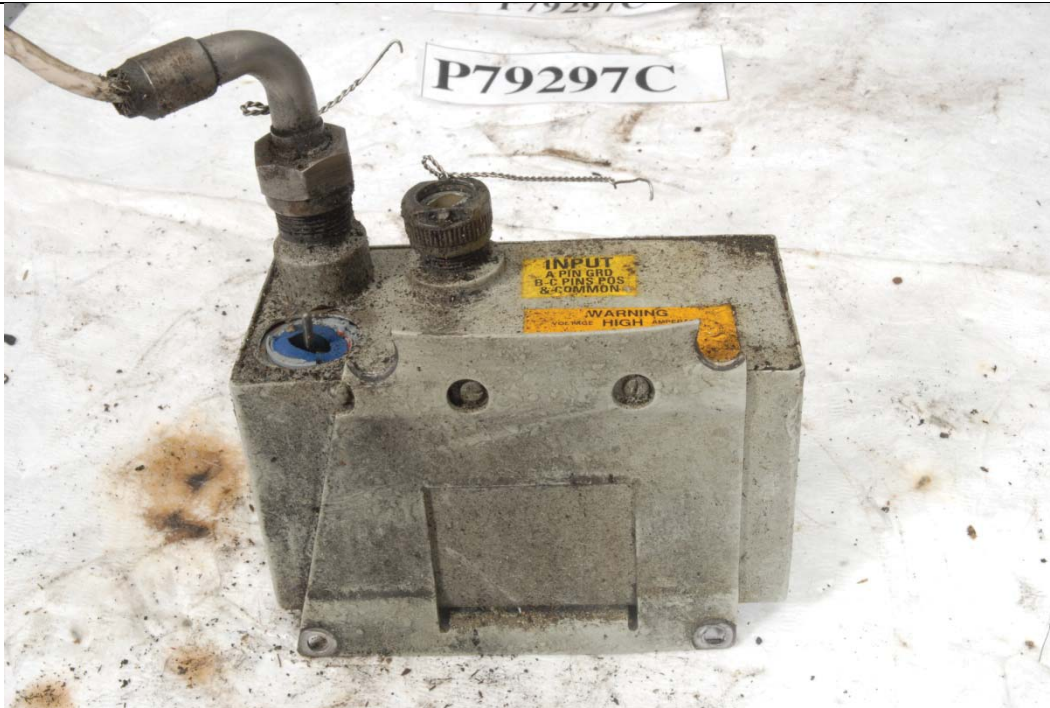
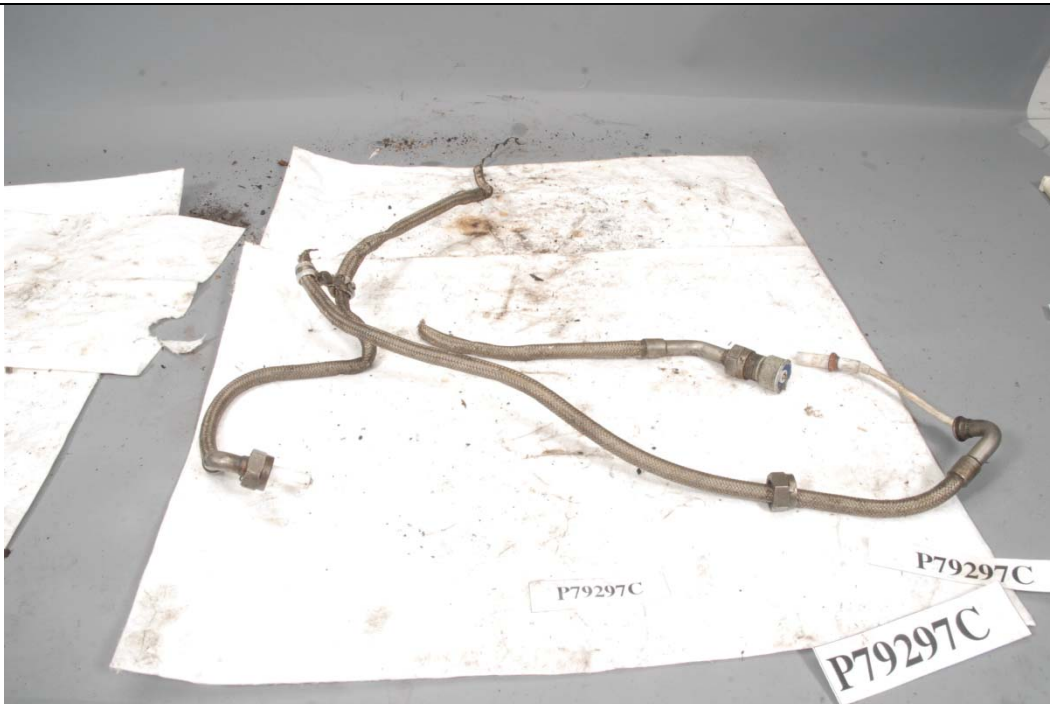
Figure 198. P-79297C, Ignition Exciter

- Earthen debris was adhering to the exterior surfaces of the ignition exciter.
- (l) Exciter to Igniter Lead Assembly: (Figure 200)
  - The exciter to igniter lead assembly was impact damaged and separated at several locations

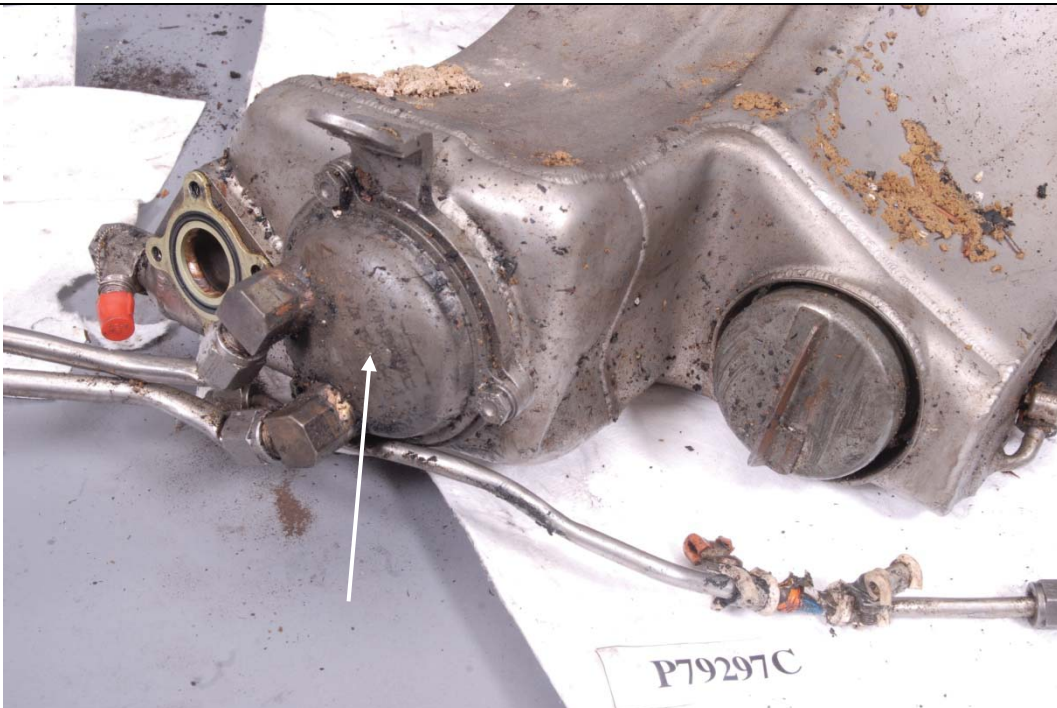
**Figure 201. P-79297C, Igniter**

- One igniter plug had been displaced inwards and was fractured at the base of the treaded portion of the igniter plug. (Figure 201)
- (n) Oil to Fuel Heater: (Figure 202)

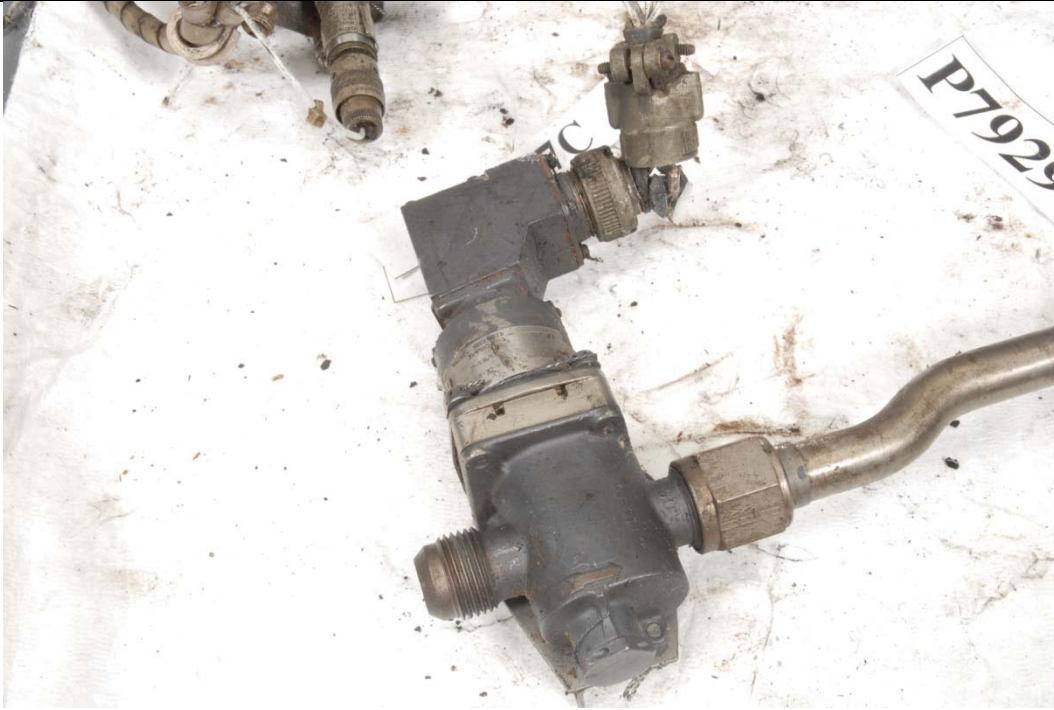
**Figure 202. P-79297C, Oil to Fuel Heater**

- The oil to fuel heater was not accessed during the examination.
  - Residual fuel was noted to be coming from the oil to fuel heater.
- (o) Anti-Ice Valve: (Figure 203)

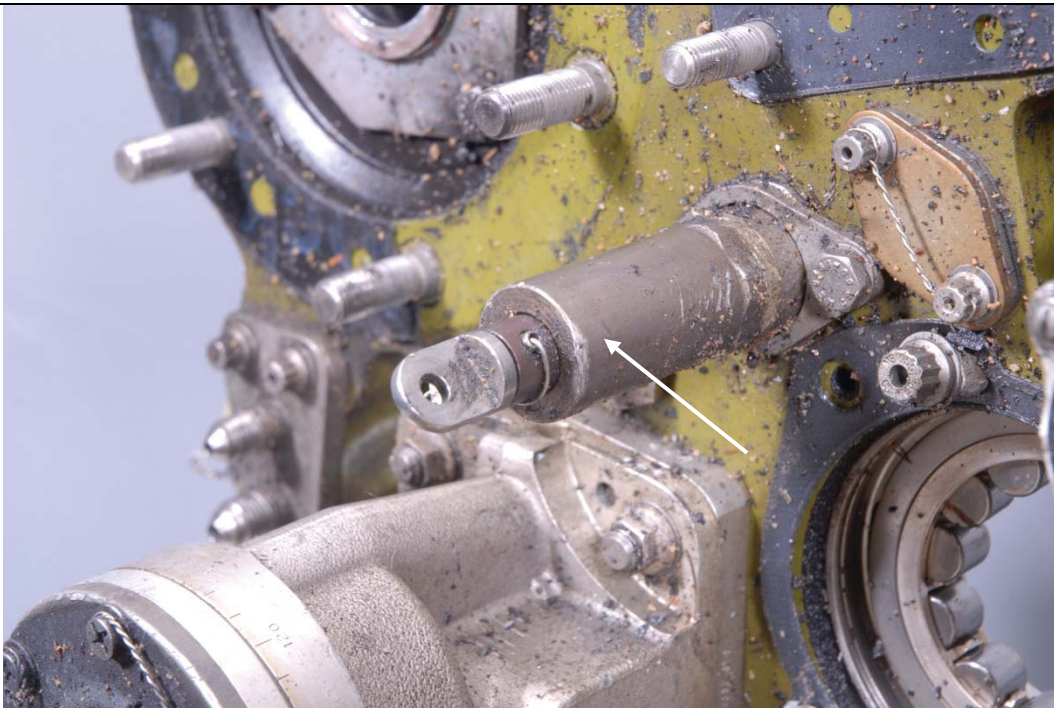
**Figure 203.** P-79297C, Anti-Ice Valve

- Part Number: 319980-1-13
  - Serial Number: P13697
  - The anti-ice valve electrical connector was separated above the attachment point.
- (p) Feather Valve: (Figure 204)

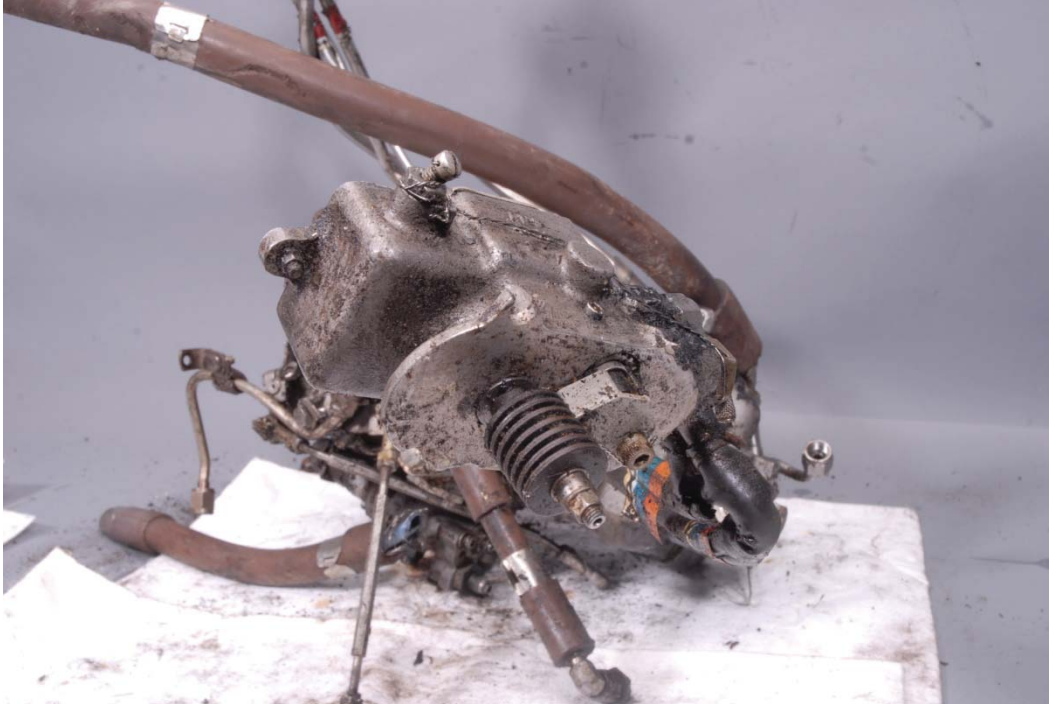
**Figure 204.** P-79297C, Feather Valve

- The feather valve appeared to be intact, and actuated freely by hand.
  - The feather valve was not disassembled from the gearcase.
- (q) P2T2 Inlet Sensor: (Figure 205)

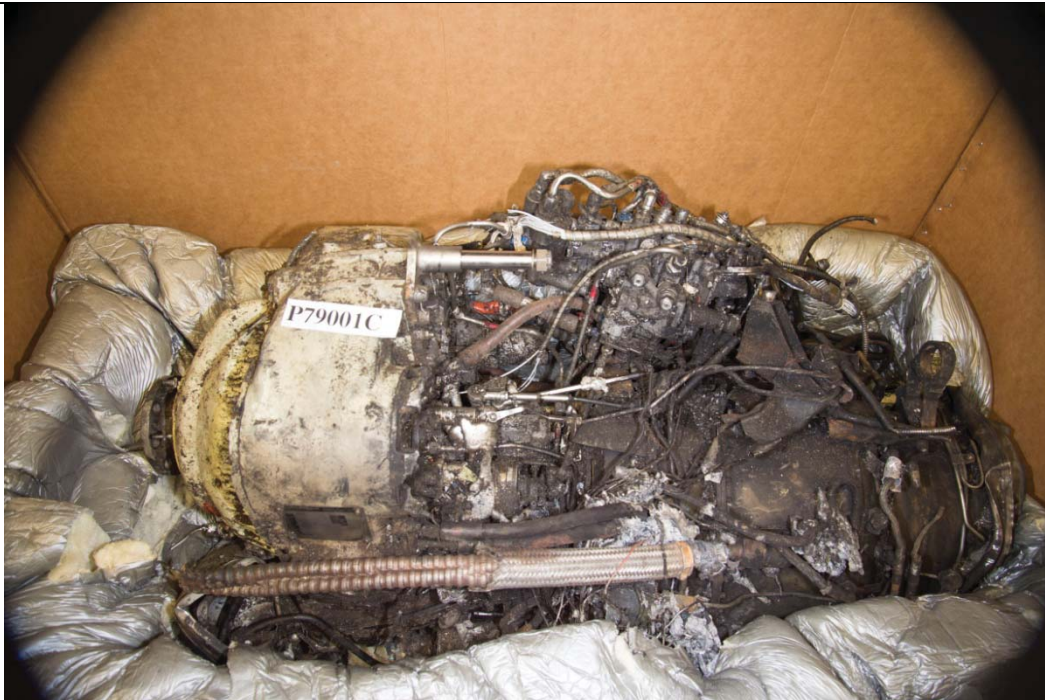
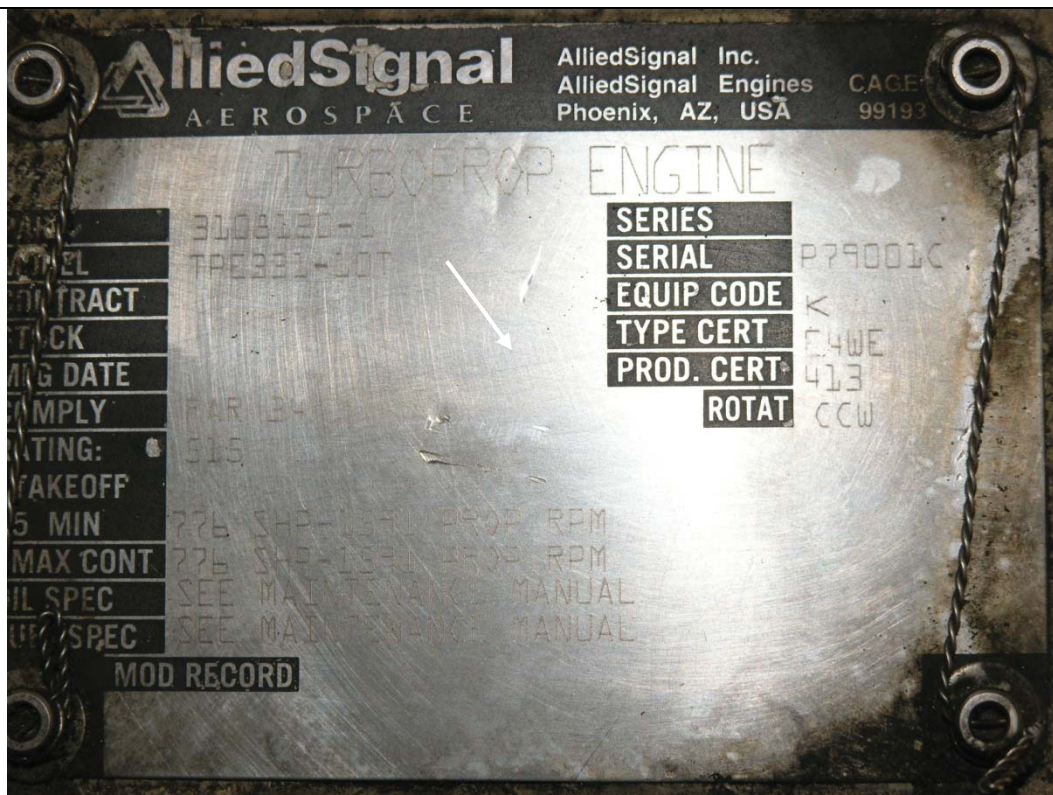
**Figure 208. P-79001C, As-Received**

- a) The engine was received in a standard shipping container. (Figure 208 and Figure 209)
- b) The engine data plate identified the engine as a Model Number TPE331-10T-515K, Serial Number P-79001C, Part Number 3108120-1. (Figure 210)

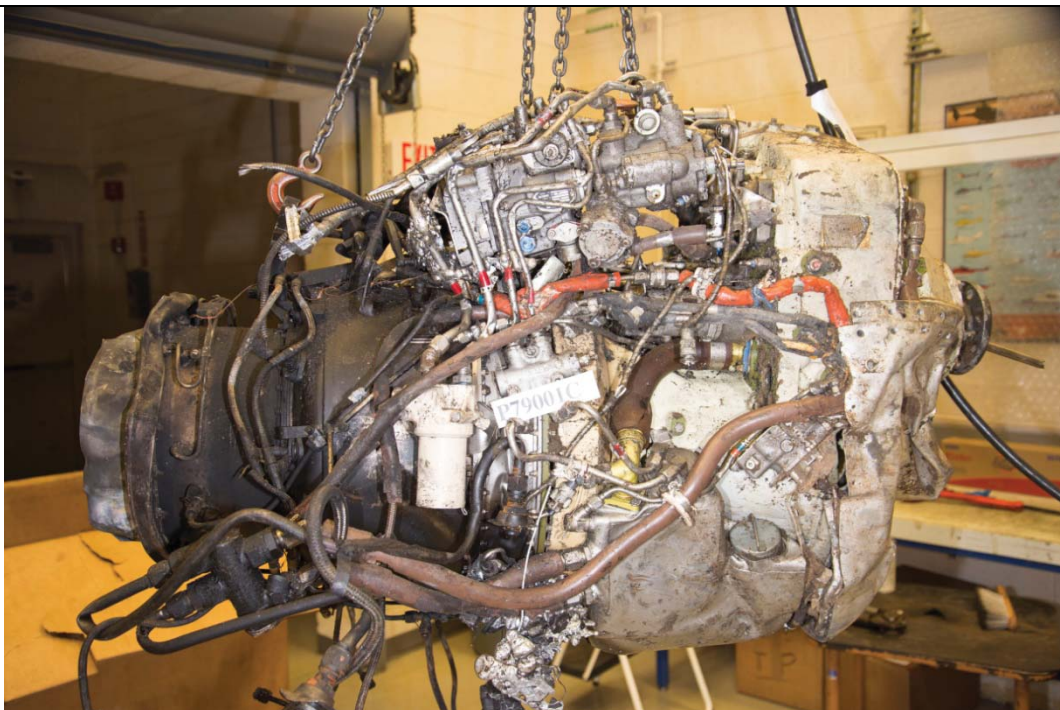
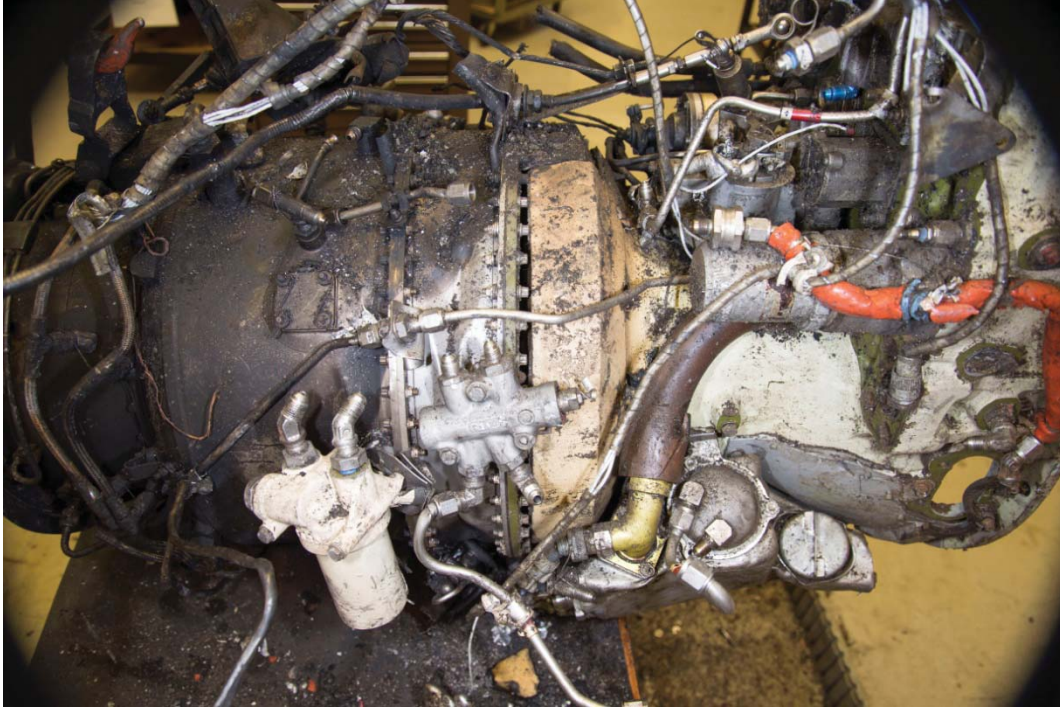
**Figure 211. P-79001C, As-Received, Left Side**

- Various engine interface control cables.
- d) The engine was generally intact however the Intermediate case was fractured at the mounting flange to the compressor case. (Figure 211, Figure 212 and Figure 213) Upon disassembly, it was noted that entire gearbox had heavy corrosion in the internal case surfaces and ferrous based components. Unless otherwise noted, all internal gear box components exhibited heavy corrosion.

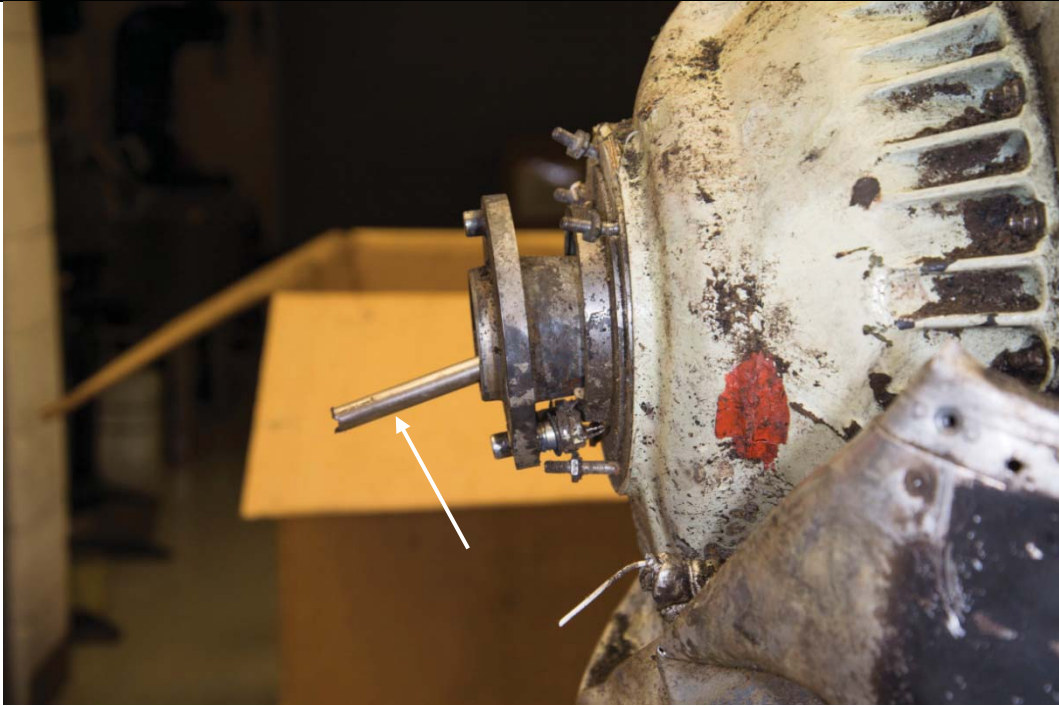
**Figure 216. P-79001C, Inlet Area**

- h) The engine's rotating group would not rotate.
- i) There was earthen debris in the air inlet area. (Figure 216)
- j) The oil flow metal (beta) tube was fractured and bent. (Figure 217) The aft portion remained in the propeller shaft.

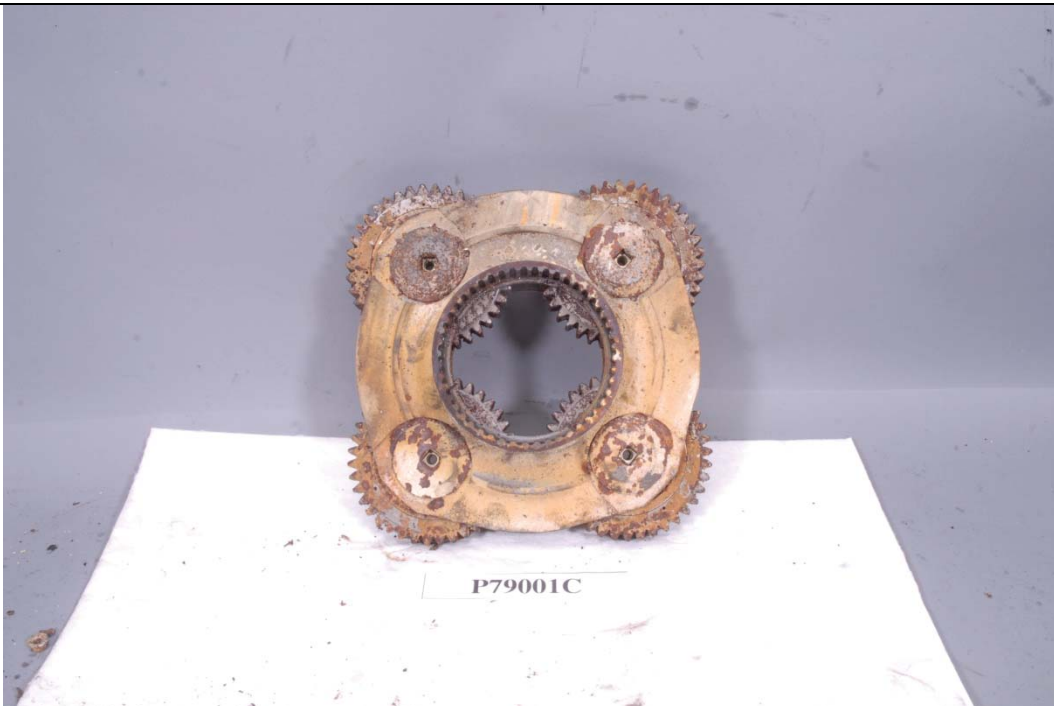
**Figure 231. P-79001C, Propeller Shaft Coupler**

- The propeller shaft bearing was not disassembled and did not rotate.
- (k) Propeller Shaft Coupler: (Figure 231)
  - The propeller shaft coupler was not disassembled from the nose cone, and was intact.

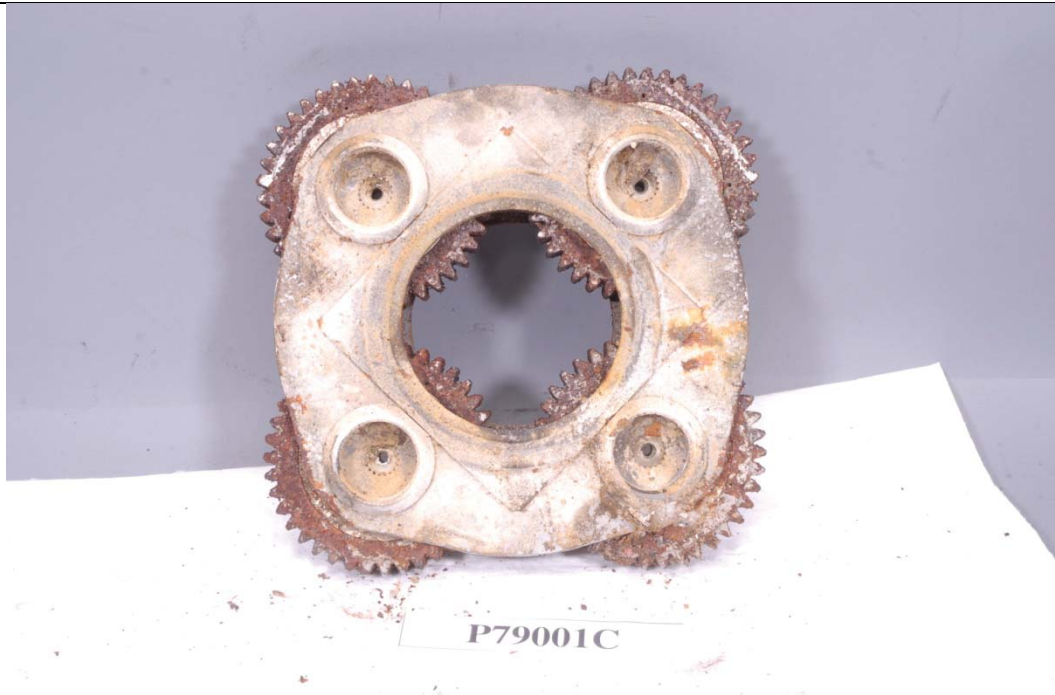
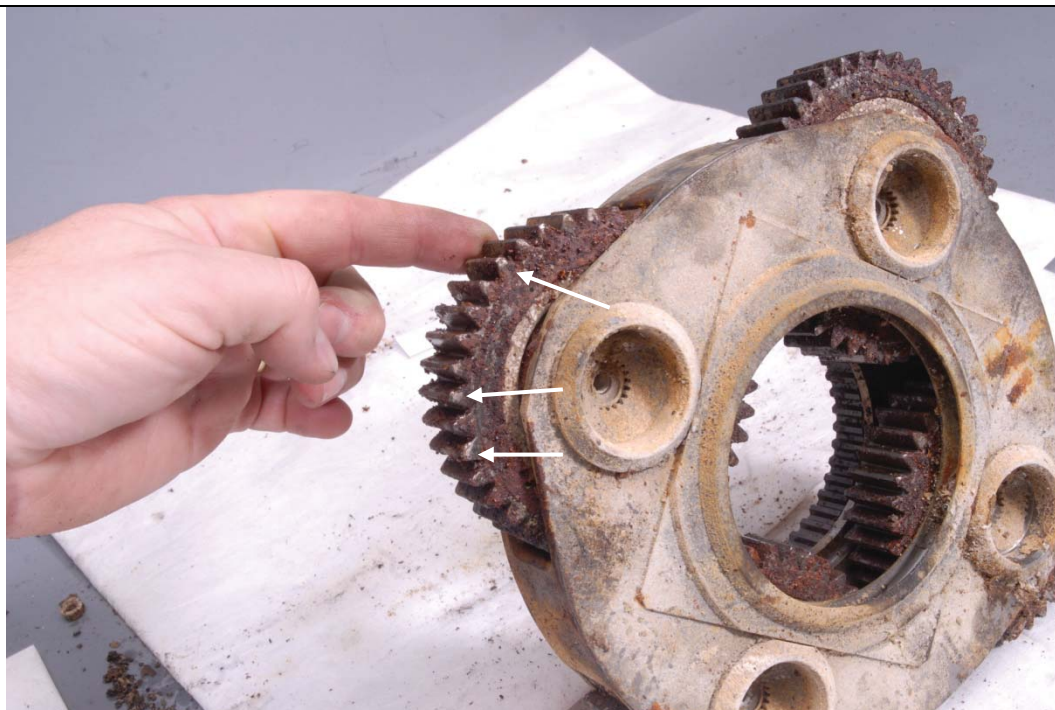
**Figure 232. P-79001C, Planetary Gear Assembly, FLA**

- (a) Planetary Gear Assembly: (Figure 232 and Figure 233)
  - The planetary gear assembly was intact.
  - All of the planetary gear assembly gears/bearings would not rotate.
  - All of the planetary gears exhibited rotational scoring to the aft face (Figure 234) with corresponding score marks on the ring gear support (bumper plate).
  - The planetary gears assembly was not disassembled for a detailed inspection.
- (b) Ring Gear: (Figure 235)
  - The ring gear was intact.

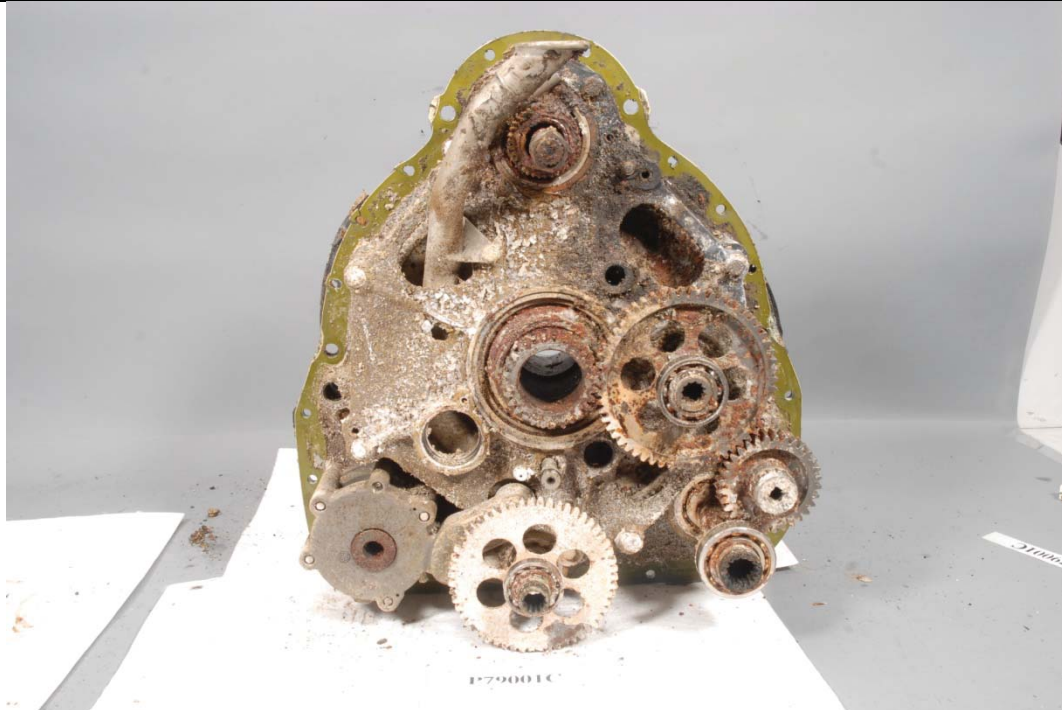
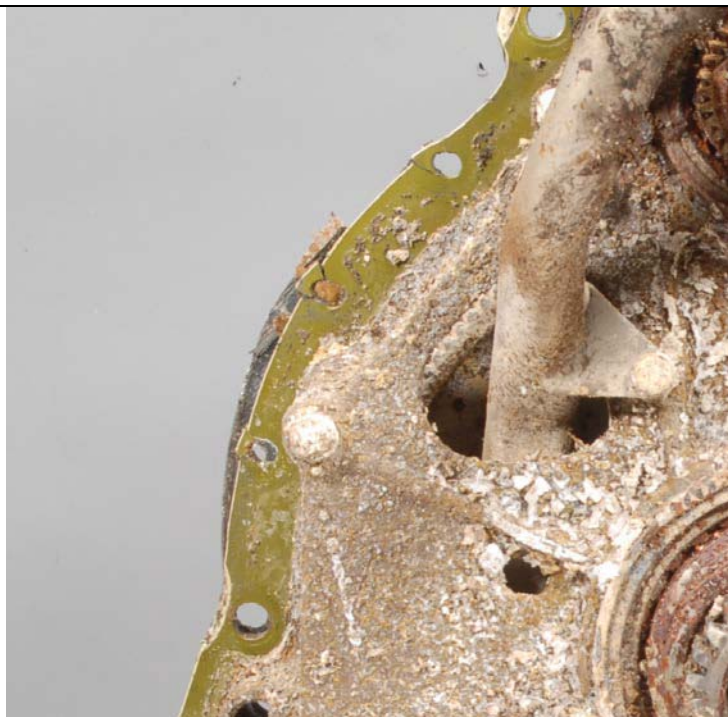
**Figure 238.** P-79001C, Diaphragm Housing, FLA

- (e) Diaphragm Housing: (Figure 238 and Figure 239)
  - The diaphragm assembly was intact.
  - All of the gears associated with the diaphragm housing were not free to rotate.
